Laser Irradiation of Carbon Fibers and Composites

J. STEPHEN EVANGELIDES
Development Group
The Aerospace Corporation
El Segundo, Calif. 90245

25 January 1979

Final Report

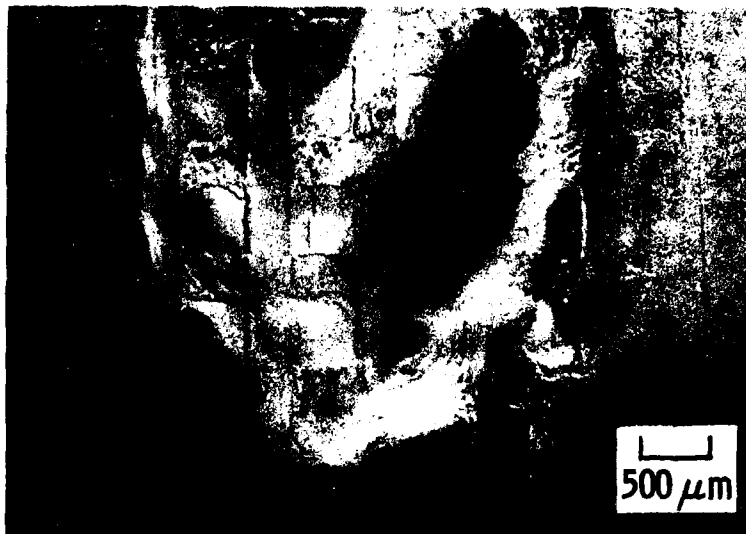
Figure 18. Scanning Electron Micrograph Top View of D2-2 Crater

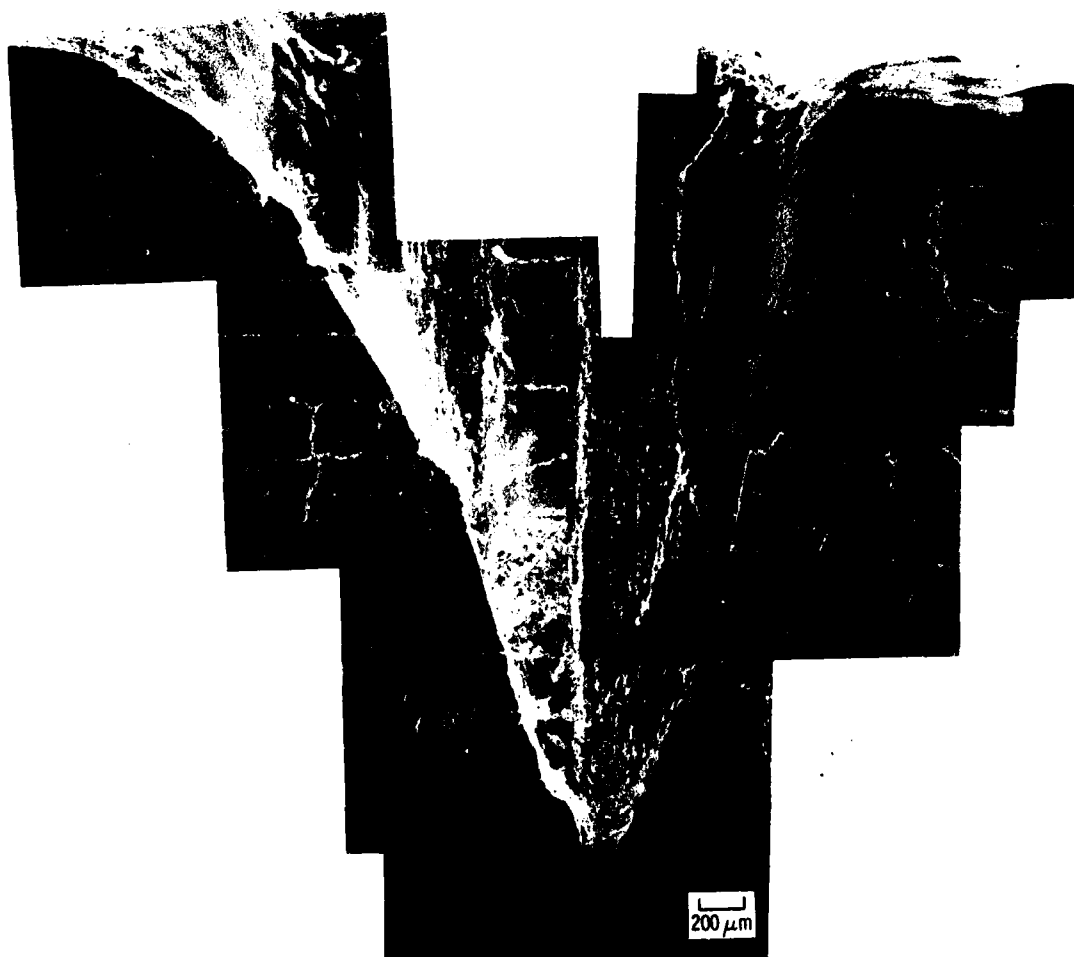
Figure 19. Scanning Electron Micrograph Side View of D2-2 Crater

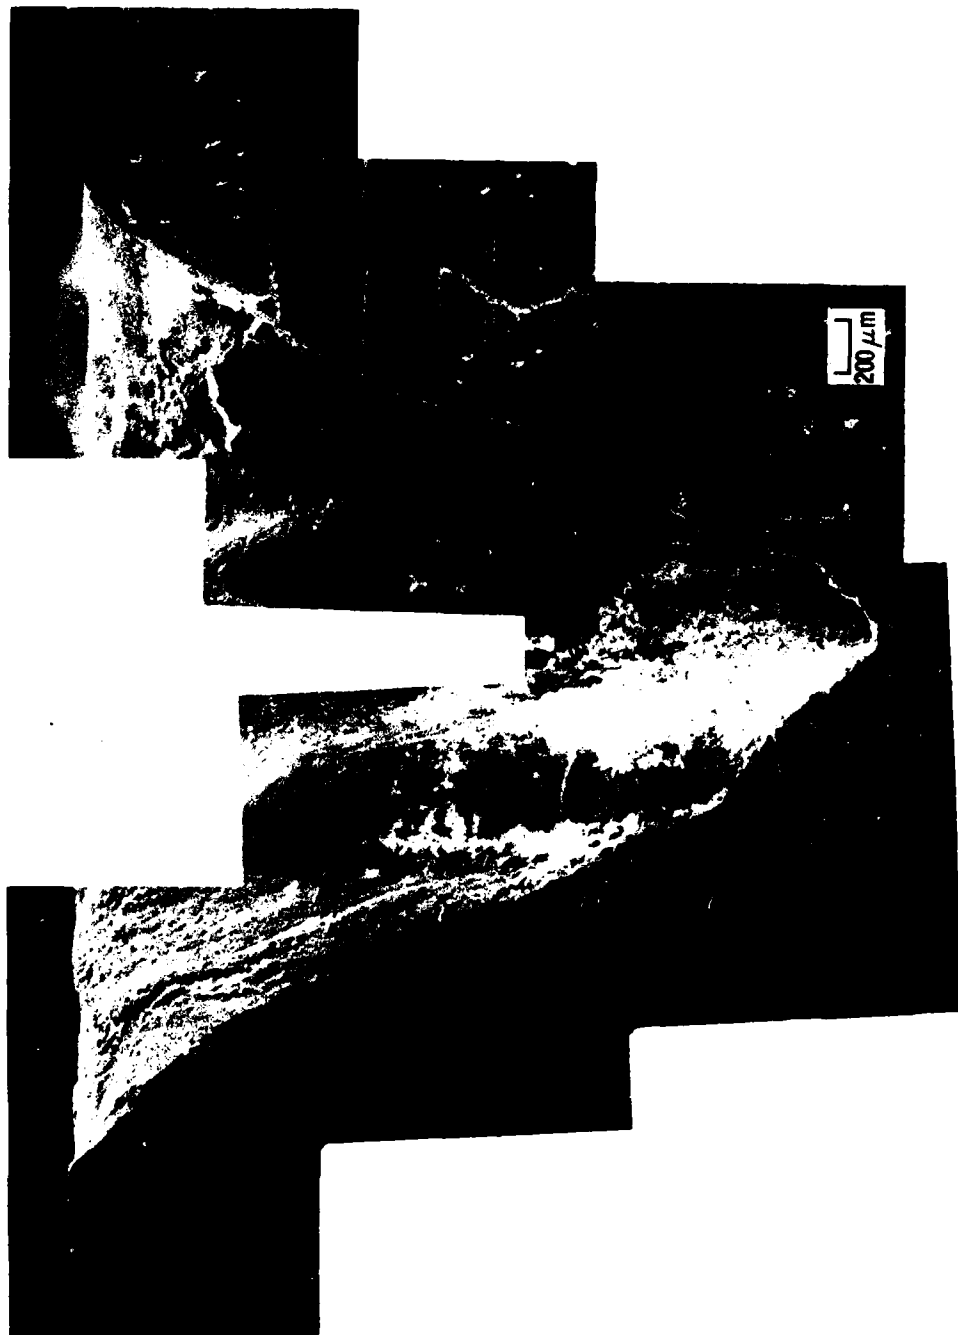
Figure 20. Scanning Electron Micrograph Side View of B1-2 Crater

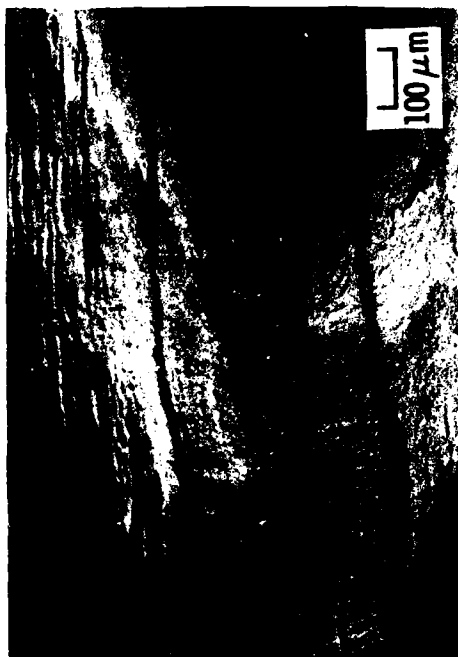
Figure 22. Scanning Electron Micrographs of a Crater in Pyrolytic Graphite
Control Sample No. 1 in C Plane

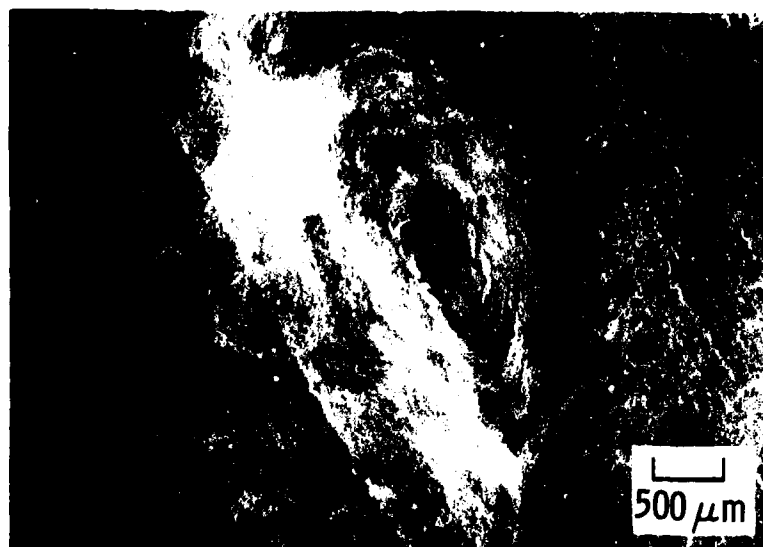
Figure 23. Scanning Electron Micrographs of a Crater in Pyrolytic Graphite Control Sample No. 1 on A-B Plane

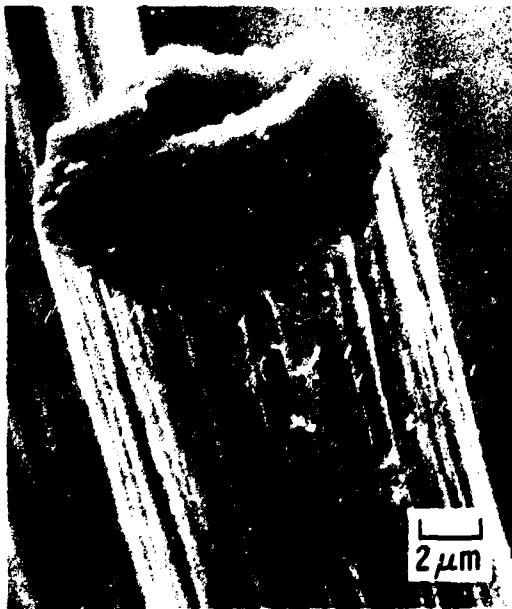
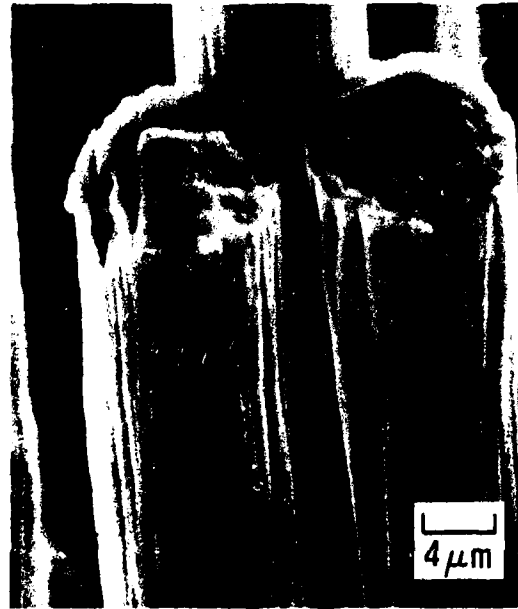
Figure 28(a). Scanning Electron Micrographs of Control Filaments Prior to Irradiation

The post-test analysis of the microstructural characteristics of individual filaments provided considerable information on filament response and structure of carbon filaments. Figure 28 shows the morphology structure and carbon filaments prior to irradiation. A summary of observations made from the scanning electron micrographs is tabulated in Table 7.

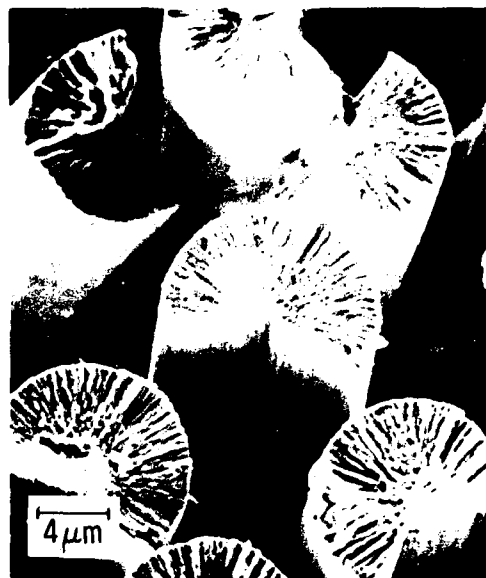
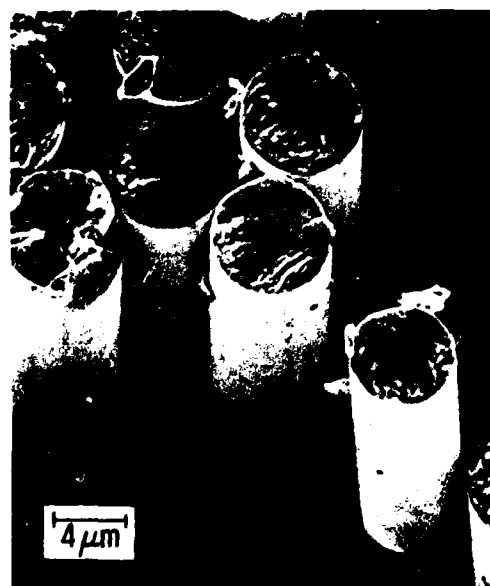
Figure 28(b). Scanning Electron Micrographs of Control Filaments Prior to Irradiation (Continued)

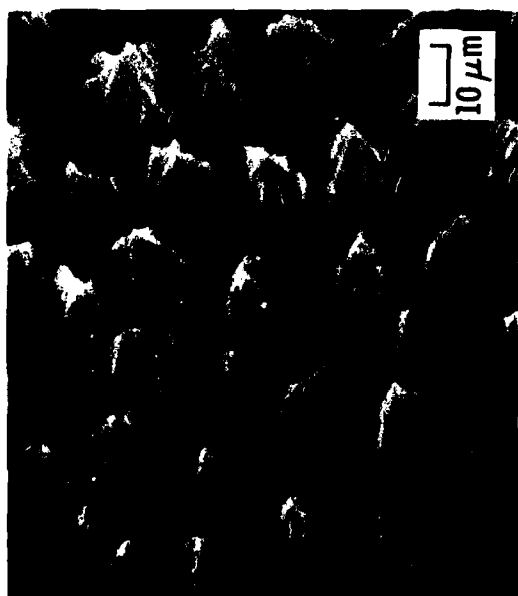
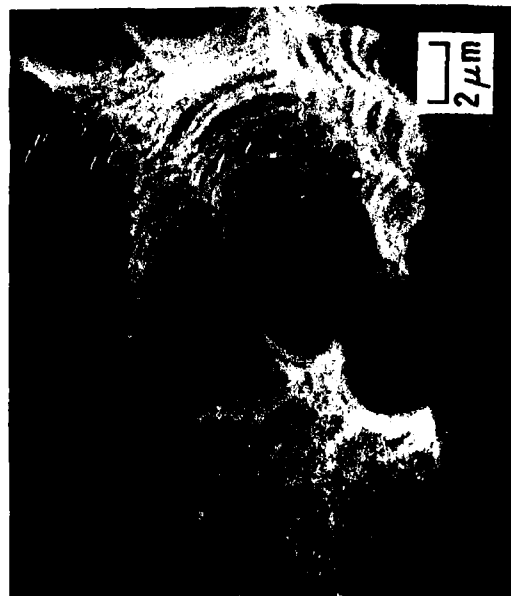
Figure 29. Scanning Electron Micrographs of WYB After Irradiation

The rayon precursor filaments after irradiation are shown in Figures 29 thru 31. The rayon filaments typically eroded to a conical or slightly pointed shape. Internal flaws and microporosity can be found. The internal structure is most apparent in the WYB filament. Groups of oriented planes appear parallel to the surface of the filament, matching the filament crenulations.

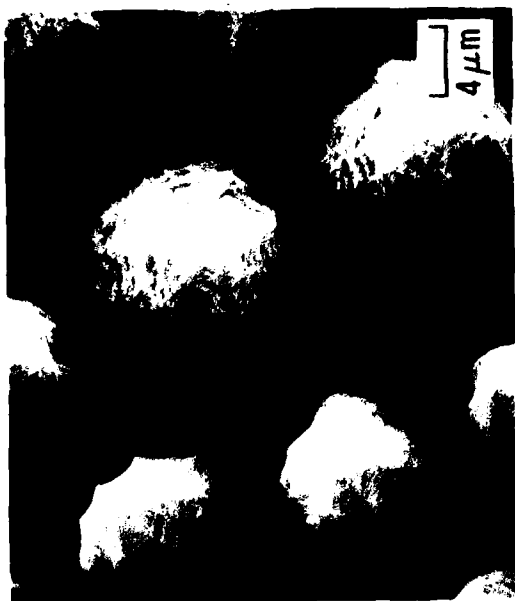
Figure 33. Scanning Electron Micrographs of Modmor 11 After Irradiation

The PAN precursor cross section filaments were cylindrical, with the exception of GY70, which was in the shape of a dog bone. After irradiation, each of the PAN filaments assumed a different characteristic shape (see Figures 32 thru 35). Thornel 300 had the most intriguing shape. An extremely thin sheath surrounded the filaments and was noticeably more erosion-resistant (see Figure 32). The filament center was the least resistant to ablation. This center region had either a very fine graphitic structure or a random structure. Filament segments or wedges radiated from the low center to the higher sheath. The ends of the Thornel 300 filament had the flattest post-test appearance. Modmor II assumed a conical shape with a circumferential structure which appeared segmented as shown in Figure 33. The HM2000 also assumed a conical shape, but with either a fine point or a flat ablation-resistant core. The HM2000 structure was uniform, with an "onion skin" or cylindrical orientation (see Figure 34). These results are similar to those obtained by Barnett and Norr.⁹ The GY 70 filaments tapered at the ends with a wedge-like appearance (see Figure 35). Occasionally a center-core pore was present. The internal structure was difficult to discern in the GY 70 filament.

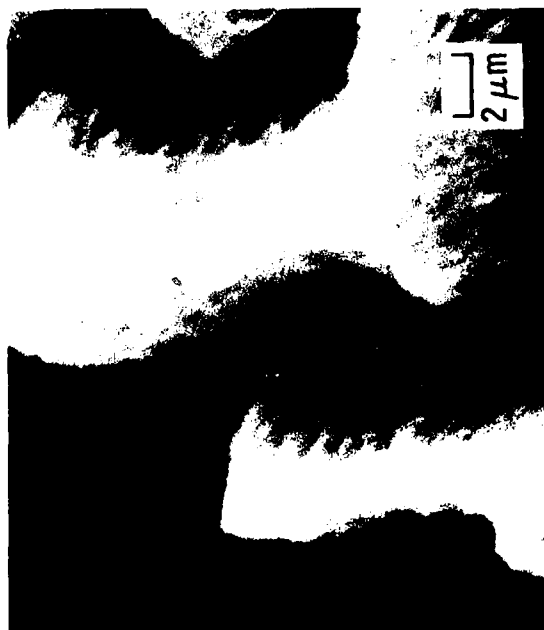
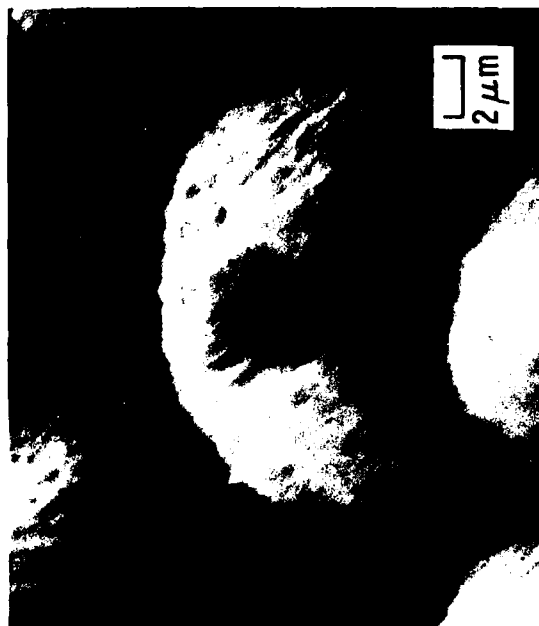
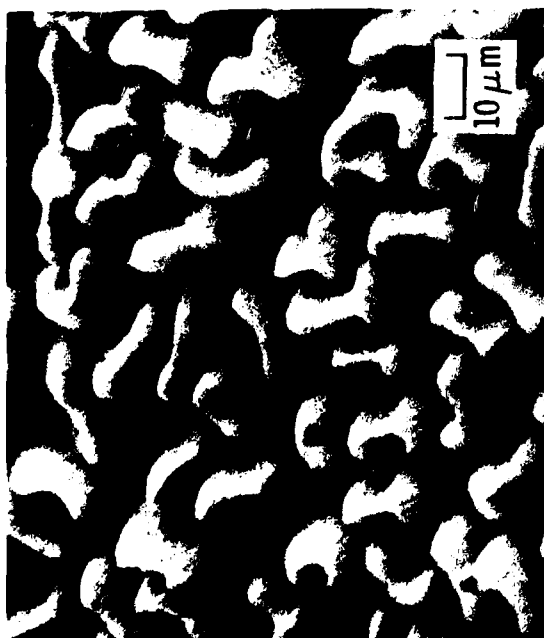
Figure 35. Scanning Electron Micrographs of GY70 After Irradiation

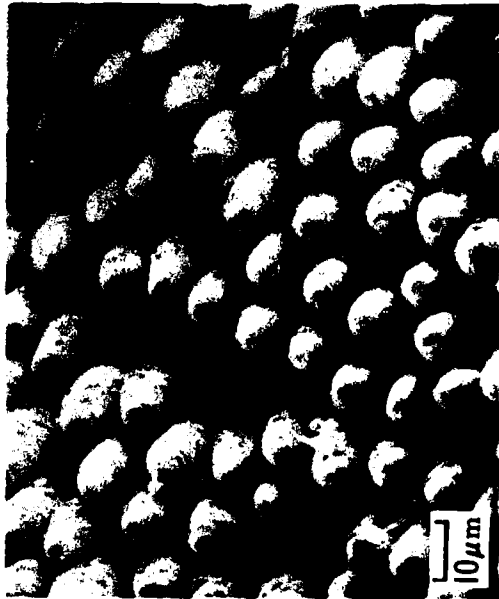
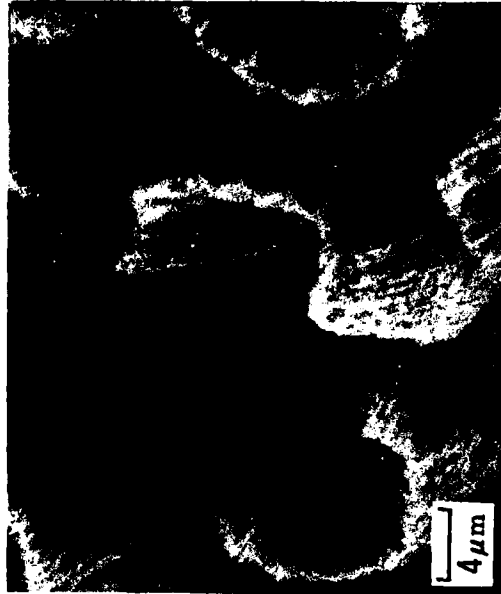
Figure 37. Filament Microstructure After Irradiation

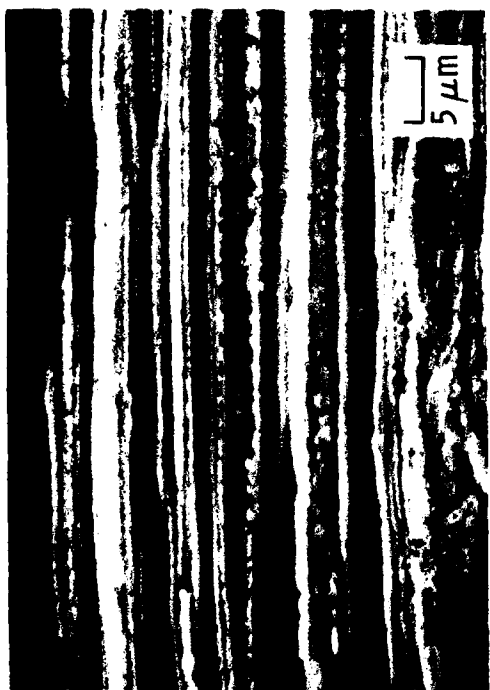
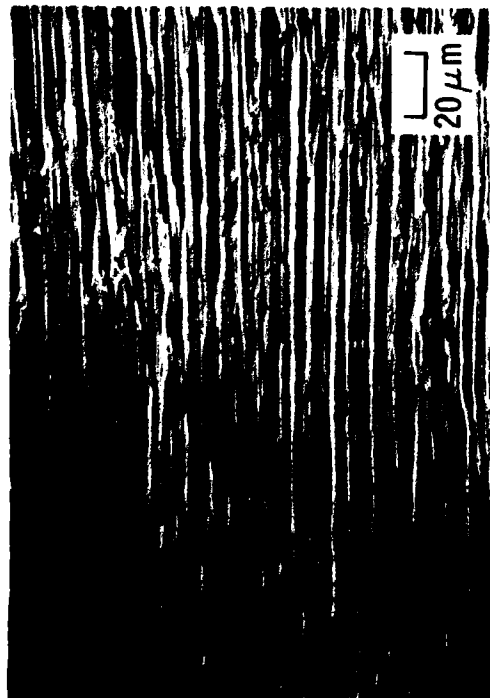
Figure 40. Scanning Electron Micrographs of a Longitudinal Filament Bundle Within a Composite Processed by Low Pressure Procedures After Irradiation

processed by low pressure procedures (AX-1) is shown in Figures 39 thru 41. The filaments oriented parallel to the laser beam were flat or slightly slanted with the matrix phase being slightly more ablation-resistant (see Figure 39). The lack of tapered filaments as in the filament tests (see Figure 37) and in composite ablation tests (see Figure 38) may be due to the less severe environment. Flat Thornel 50 filaments were observed near the edges of the transverse craters for the bare filament experiments. For the filaments oriented normal to the laser beam, both filament and matrix can be found (see Figure 40). Also shown in Figure 40 is a filament fracture which could have occurred during the final graphitization step during processing. Although it could have occurred during the laser experiment, no other evidence of fracturing or microdamage could be found in the composite samples. The cross-sectional views through the crater did not reveal any evidence of mechanical damage in any of the constituents, filament ends, filament sides, or bulk matrix (see Figure 41). The transverse filament, bulk matrix, and longitudinal bundle (in order of decreasing recession) were similar to those observed during ablation testing. There was little difference between the bulk matrix and longitudinal bundles in either this experiment or in the ablation tests. This is consistent with the results discussed previously when the constituents were tested individually.
